PSN # PSN004095u

Original publication date: 31-Oct-13, This is Issue #02, published date: 12-Dec-13. Severity/risk level Medium Urgency Optional

Name of problem Avaya CS1000 CPPM pack memory module can fail causing service outage

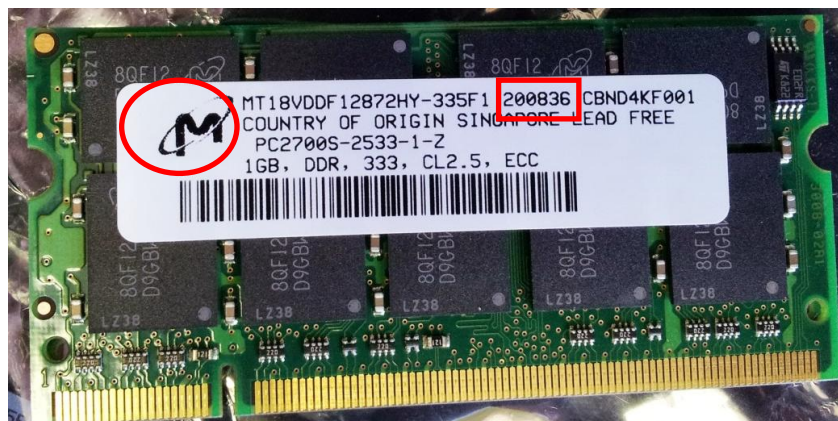
The root cause is a failed memory module. The issue correlates to a Micron Technologies product defect involving semiconductor devices on the 1GB DDR333 memory modules with date codes earlier than January 2011. The memory module exhibits early life failure after approximately five (5) years of service. The defect will only show up after a power cycle, as the root cause is a silicon failure in the device's power up circuitry.

The suspect modules can be identified visually by the label on the memory DIMM. If the vendor symbol matches what is circled below (M for Micron) and the date code (yyyy ww) is prior to 2011 01 , the module should be replaced.

Avaya recommends replacing all memory modules on CPPM packs which are Micron Technologies with date codes prior to 2011 01. Micron modules with later date codes and modules from other vendors are not affected by this issue.
