Release Notes — Software Release 7.2

Avaya Ethernet Routing Switch 8800/8600

Release 7.2
NN46205-402
Issue 09.07
March 2014

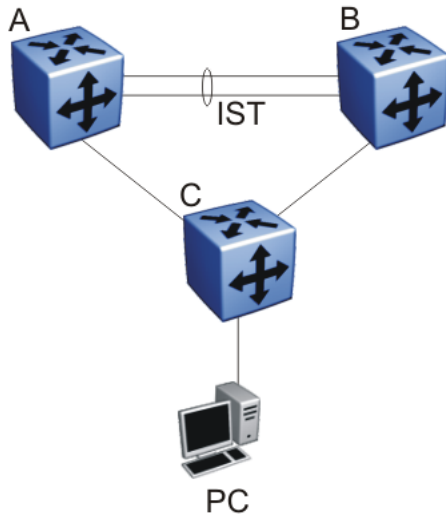
Figure 1: SMLT upgrade scenario

Consider the following figure, showing a triangle SMLT setup. In this case, the user intends to upgrade the IST peers (that are currently running 5.1.0.0) to 7.2.0.0.

Assume the user Telnets from the PC to manage switch A and switch B. When the Telnet traffic generated by the PC arrives at switch C, depending on the MLT hashing algorithm, the traffic can be hashed to the link toward switch A or switch B. So, it is possible to have a situation where the Telnet management traffic destined for switch A flows through switch B and vice-versa.

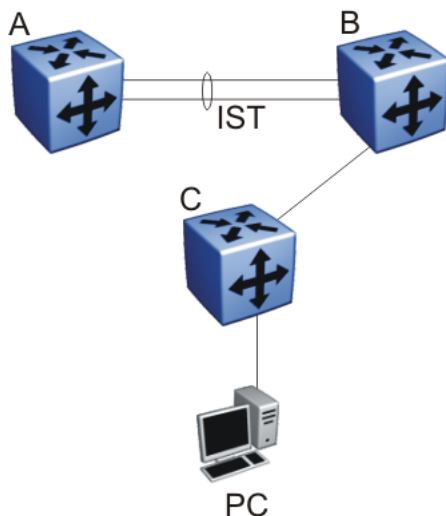
Figure 2: SMLT upgrade scenario after upgrading switch A to 7.2.0.0

Assume that the user upgrades switch A to 7.2.0.0. Due to the SMLT behavior, the network diagram now looks like the following figure.

In this situation the PC cannot communicate with switch A, and as a result Telnet access to switch A is unavailable. For in-band management, you can alternatively Telnet first into switch B, and then Telnet to switch A from there.
